Kingdom Community Wind Sound Compliance Testing Report: Fall 2012

26 February 2013

Prepared by
Resource Systems Group, Inc.
for
Green Mountain Power Corporation

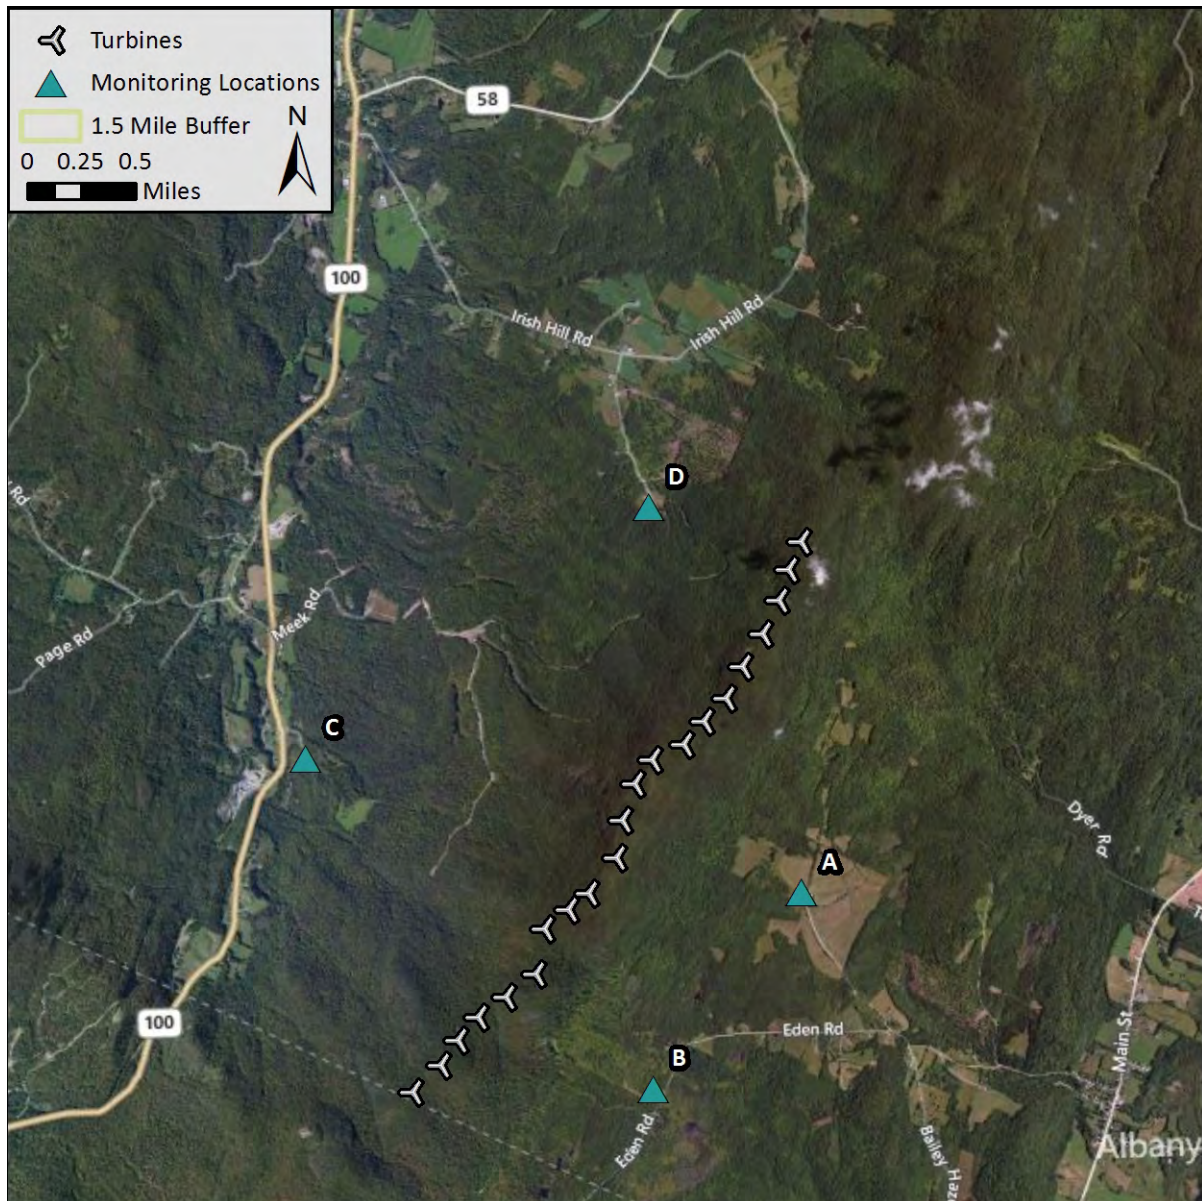
A map of the area is provided in Figure 3. Figure 3 also shows the four monitoring locations that were chosen according to the Monitoring Protocol and defined in the *Kingdom Community Wind: Preliminary Sound Monitoring Report* dated November 2012 (Preliminary Monitoring Report). Additional details on the monitoring locations are provided in Section 4.6 of this report.

Figure 3: Area Map with Monitoring Locations

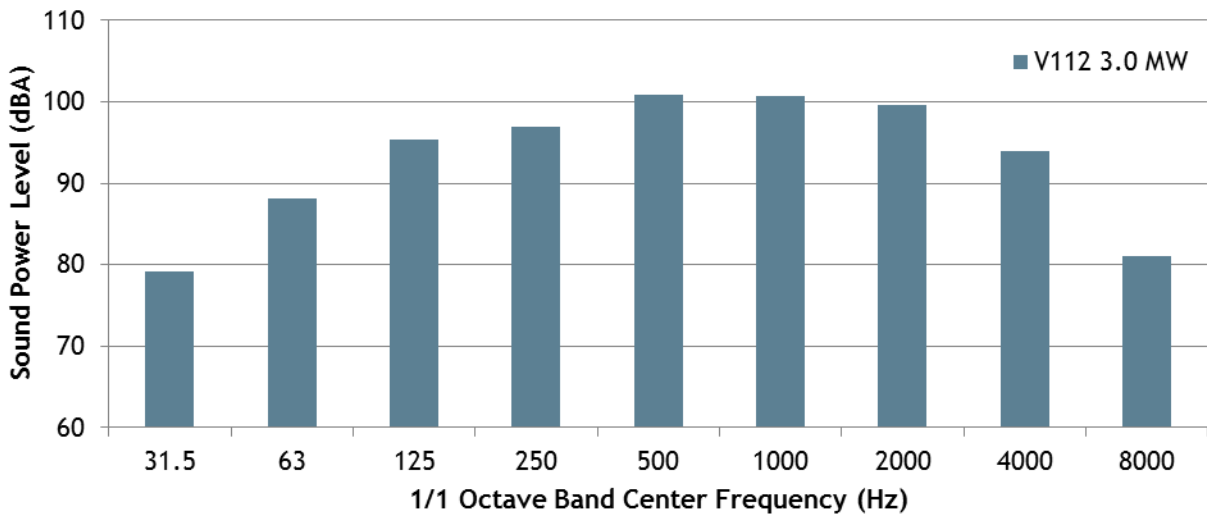
The project is composed of 21 Vestas V112 3.0 MW wind turbines. The V112 is a pitch regulated wind turbine with a hub height of 84 meters. The turbine operates at variable rotor speeds with electronic controls to help minimize sound emissions at certain times (Noise Reduced Operations or NRO). The guaranteed maximum sound power level from the V112 is 106.5 ± 2.0 dBA. Sound power levels by wind speed and by octave band are provided in Figure 4 and Figure 5, respectively.

Figure 5: Sound Power Level (dBA) of the Vestas V112 by 1/1 Octave Band Frequency

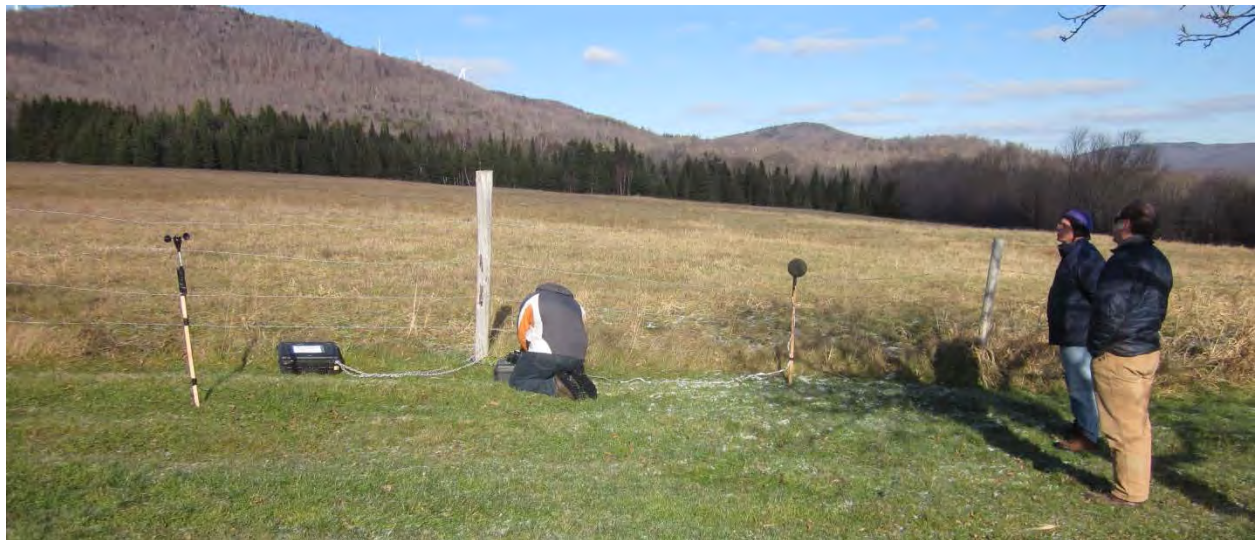
Figure 8: Photograph of the Monitor A Primary Monitoring Location

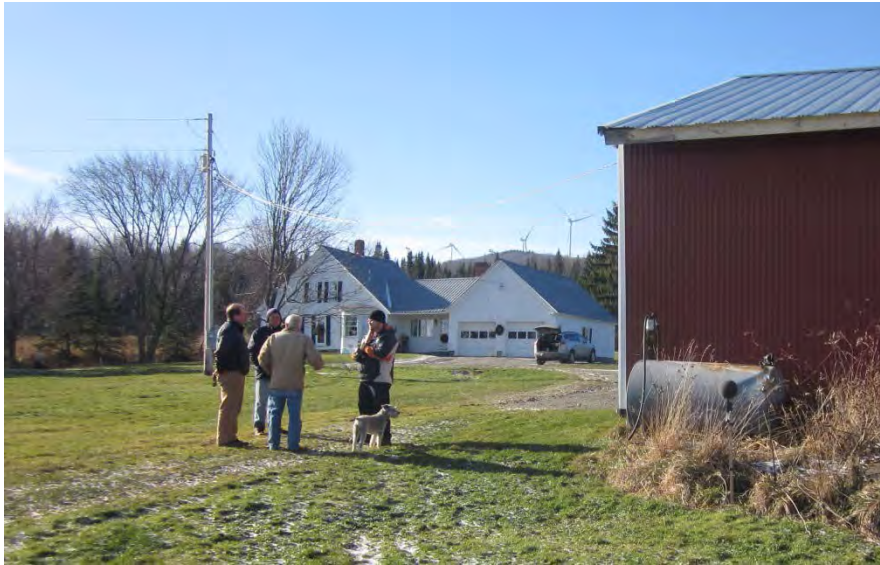
Figure 9: Photograph of the Monitor A Background Monitoring Location

A map of the primary and background monitor locations at Monitor A is provided in Figure 7, and photographs of the two locations are provided in Figure 8 and Figure 9.

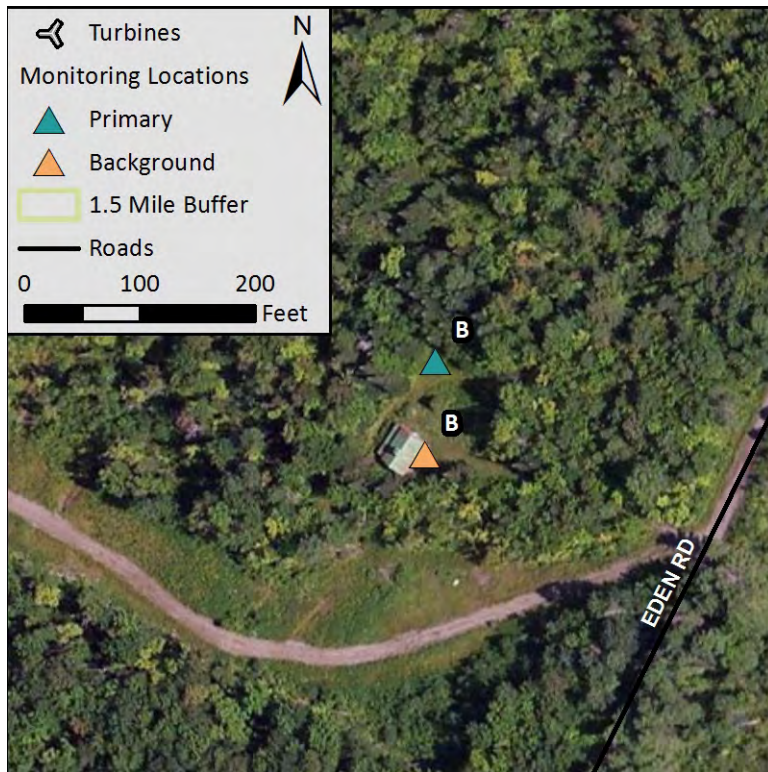
A map of the primary and background monitor locations at Monitor B is provided in Figure 10, and photographs of the two locations are provided in Figure 11 and Figure 12.

Figure 10: Monitor B (Eden Road) Primary and Background Monitoring Location Map

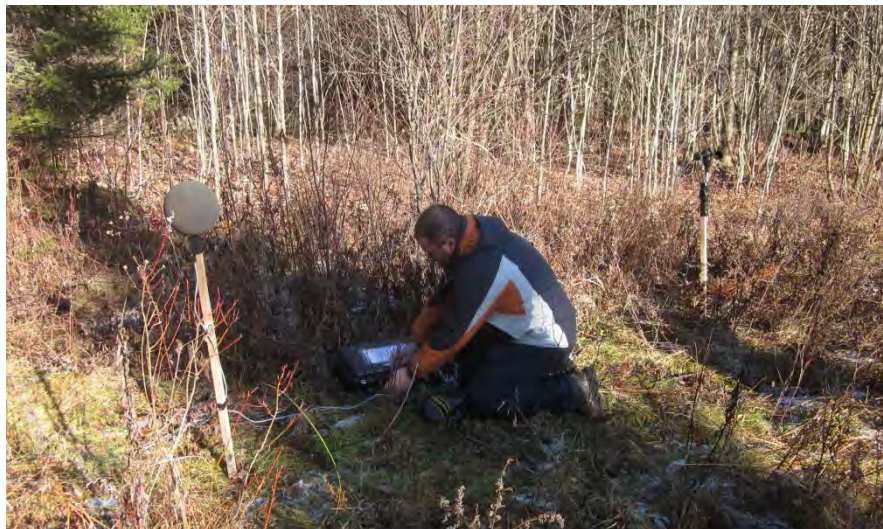
Figure 11: Photograph of the Monitor B Primary Monitoring Location

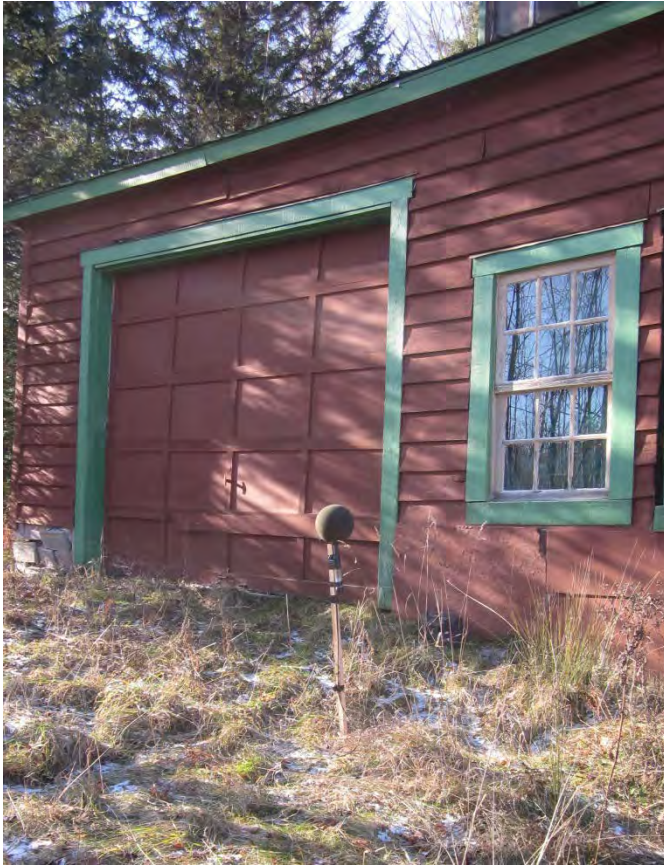
Figure 12: Photograph of the Monitor B Background Monitoring Location

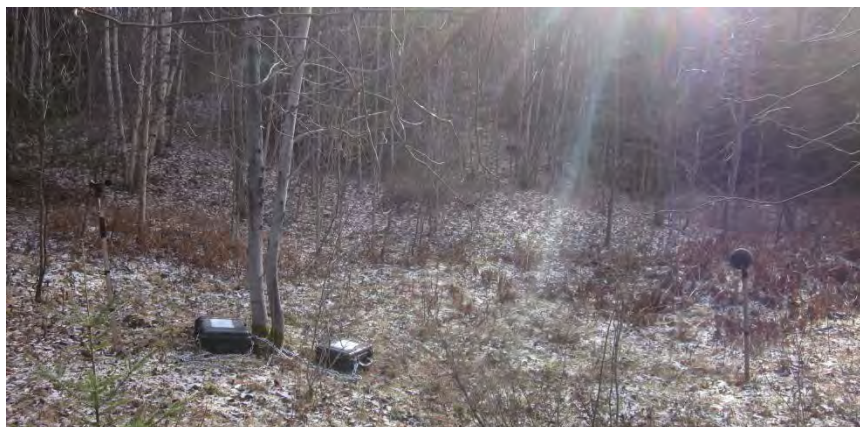
Figure 14: Photograph of the Monitor C Monitoring Location

A map of the monitor location at Monitor C is provided in Figure 13, and a photograph of the location is provided in Figure 14.

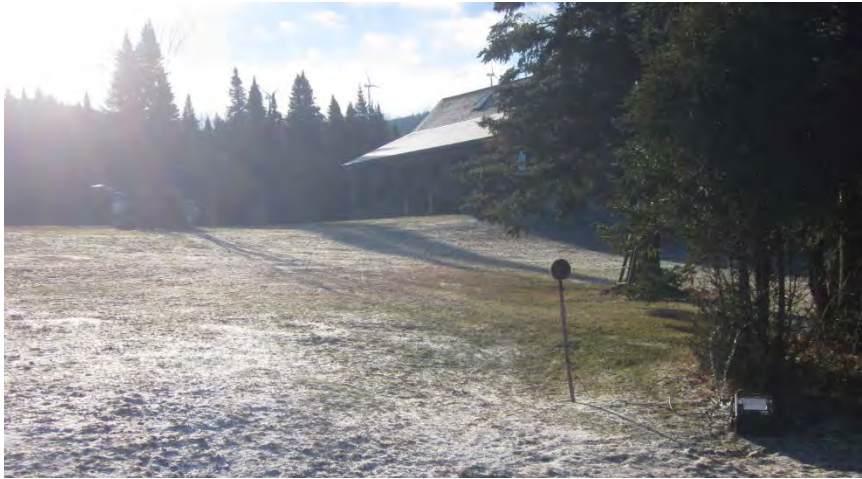
Figure 16: Photograph of the Monitor D Primary Monitor Location

A map of the primary and background monitor locations at Monitor D is provided in Figure 15, and photographs of the two locations are provided in Figure 16 and Figure 17.

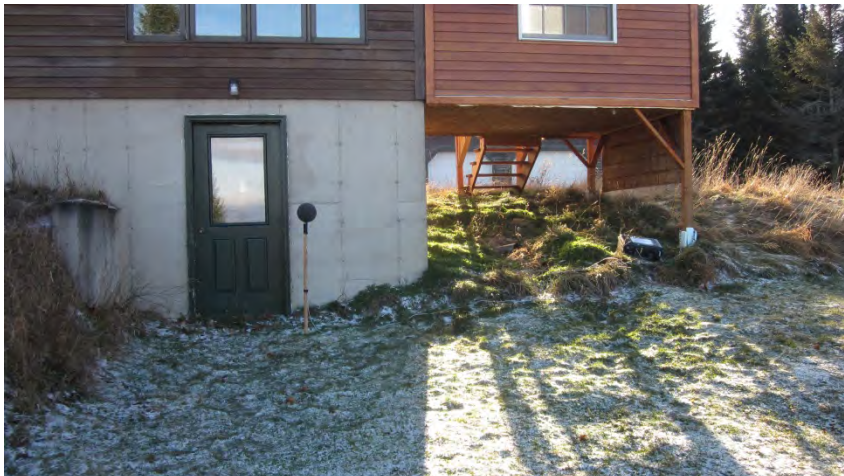
Figure 17: Photograph of the Monitor D Background Monitor Location

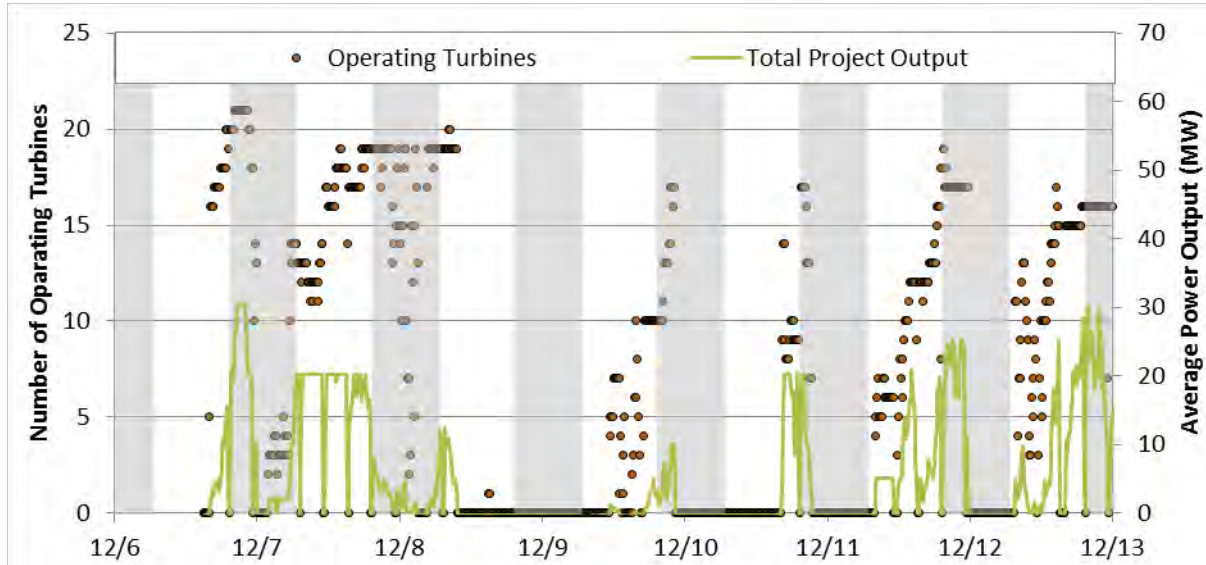
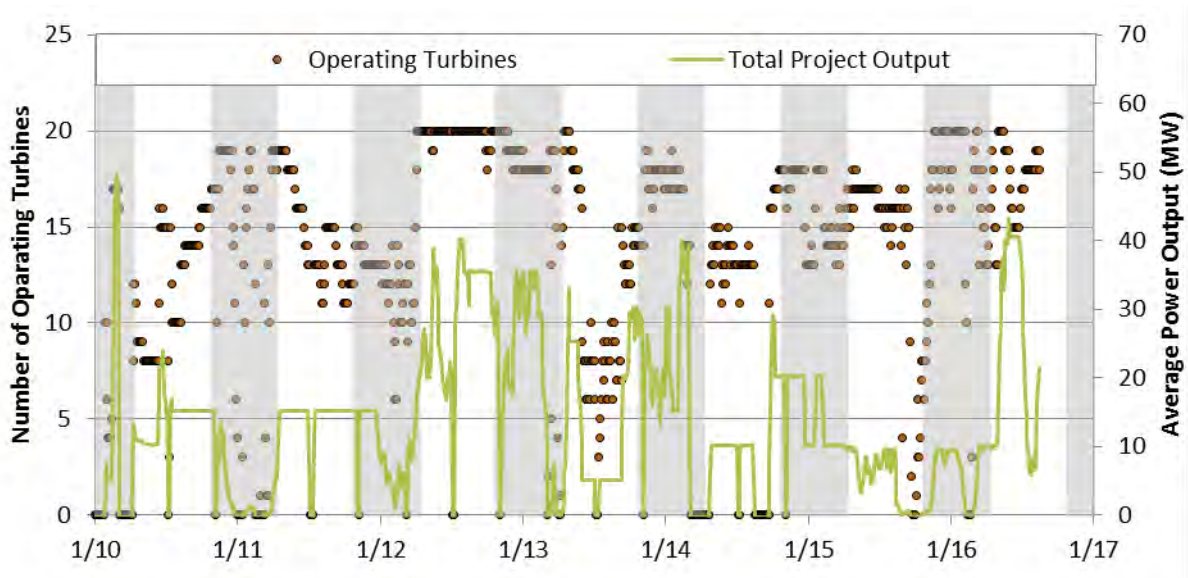
- Some extended periods where no turbines were operating such as portions of December 8, 8, 10, and 11, and periods of several days such as December 18 to December 21 or December 29 to January 4. RSG’s understanding from GMP is that KCW was limited by ISO New England at the beginning of the monitoring period to a limited total power output, and turbines were curtailed for some periods at the end of December due to blade icing issues.

Figure 18: Project Activity - Part 1

Figure 19: Project Activity - Part 2

Figure 20: Project Activity - Part 3

Figure 21: Project Activity - Part 4

Figure 22: Project Activity - Part 5

Figure 23: Project Activity - Part 6

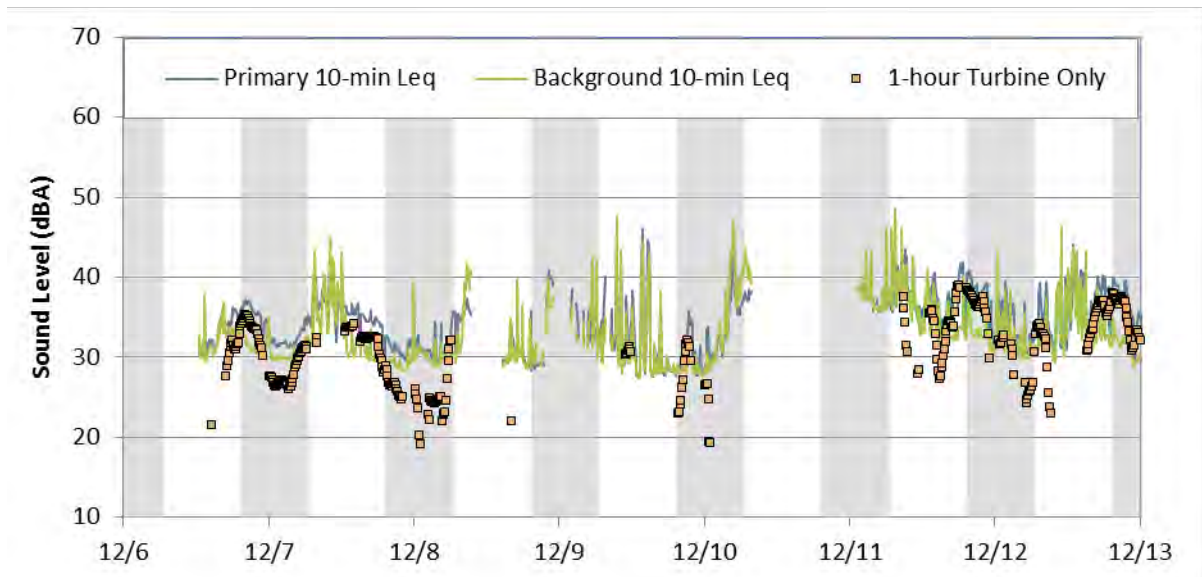
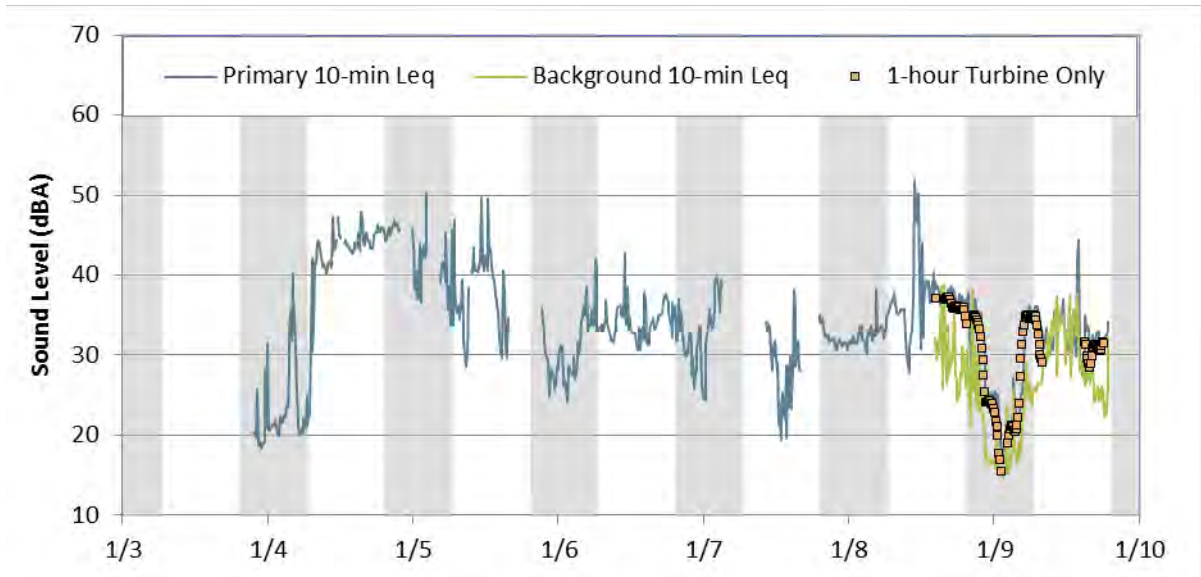
monitor is denoted by the dark blue line and the same acoustical parameter at the background monitor is shown in green. As discussed in Section 4.4.1, the 10-minute equivalent sound level at the background monitor was logarithmically subtracted out of the 10-minute equivalent sound level at the primary monitor resulting in a 10-minute equivalent sound level due to the project's wind turbines. For purposes of testing compliance with the project's permit conditions, the data was then summarized into a 1-hour equivalent sound level due to the project's wind turbines which is denoted in the figures by the light orange dots (1-hour Turbine Only). "Turbine Only" sound levels are the sound levels used for comparison with the CPG limit of 45 dBA (Leq_{1-hour}) and represent the sound level caused by the project not background sound.

Figure 24: Nelson Method 3 Analysis Results - Part 1

Figure 25: Nelson Method 3 Analysis Results - Part 2

Figure 26: Nelson Method 3 Analysis Results - Part 3

Figure 27: Nelson Method 3 Analysis Results - Part 4

Figure 28: Nelson Method 3 Analysis Results - Part 5

Figure 29: Nelson Method 3 Analysis Results - Part 6

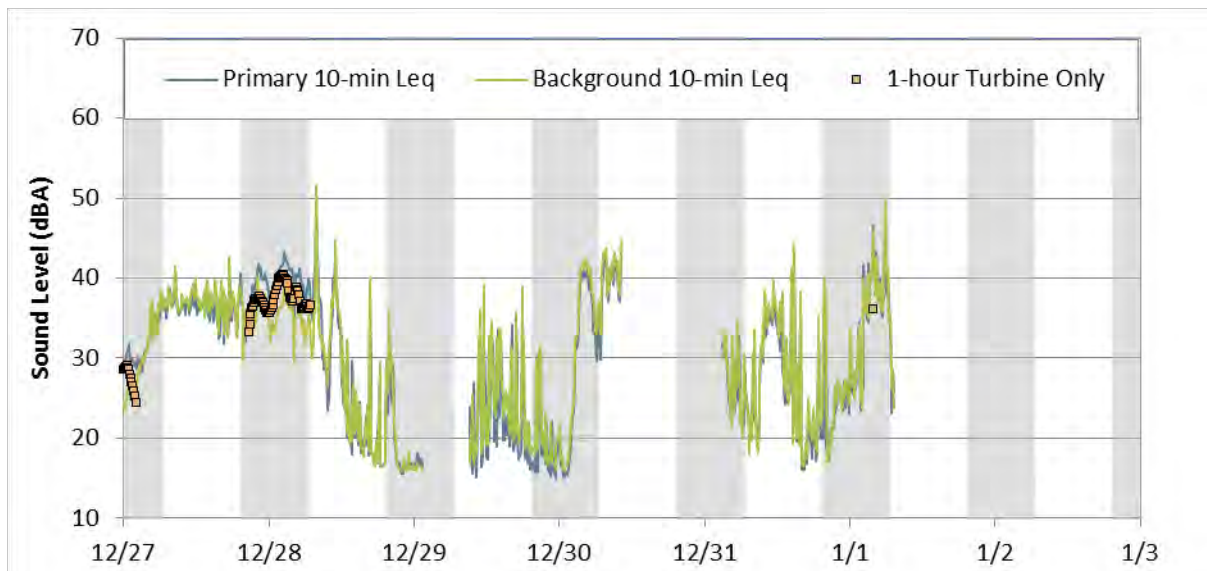
There were no exceedances of the 45 dBA outdoor limit at Monitor B using Method 3.

Figure 31: Eden Road Method 3 Analysis Results - Part 1

Figure 32: Eden Road Method 3 Analysis Results - Part 2

Figure 33: Eden Road Method 3 Analysis Results - Part 3

Figure 34: Eden Road Method 3 Analysis Results - Part 4

Figure 35: Eden Road Method 3 Analysis Results - Part 5

Figure 36: Eden Road Method 3 Analysis Results - Part 6
